Effect of severe hurricanes on Biorock Coral Reef Restoration Projects in Grand Turk, Turks and Caicos Islands

Lucy Wells¹, Fernando Perez¹, Marlon Hibbert¹, Luc Clerveaux¹, Jodi Johnson¹ & Thomas J. Goreau²

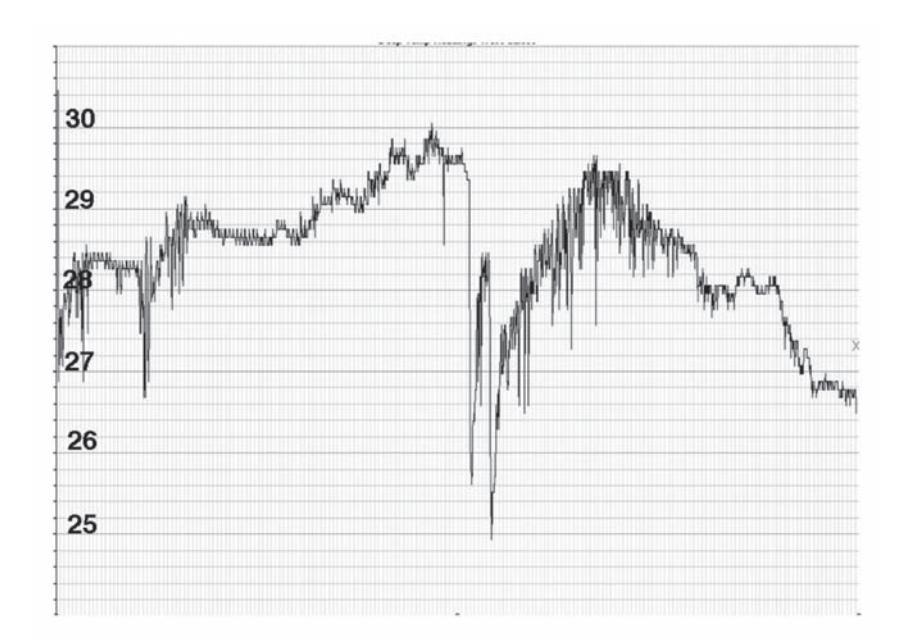
Marine impacts: Temperature and light logs: A recording datalogger measured temperature and light levels before, during, and after these hurricanes at a location 43 m deep in West Caicos. Temperatures plunged around 4°C after Hanna, rose about 2.5°C before Ike, and then dropped around 3.5°C after Ike. It took about a month to regain normal temperatures (Fig. 1). Light measurements indicated near complete light extinction at depth during the week of the hurricanes, and that fine suspended particulates kept light levels roughly one tenth of normal for the succeeding four months (Fig. 2).

Fig. 1. Temperature records in degrees celsius from May 24 to December 9, 2008 logged at West Caicos by DECR. The first dramatic decrease marks Hurricane Hanna, the second is Hurricane Ike.

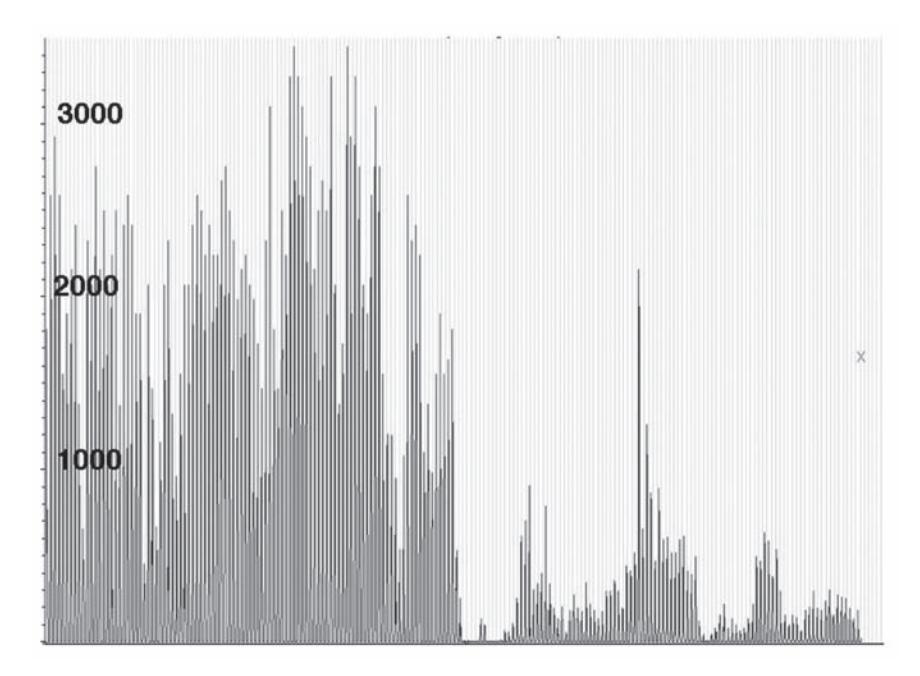
Fig. 2. Light records in lux logged from May 24 to December 9, 2008 at West Caicos by DECR. Light levels plunged after the hurricanes and remained low the rest of the year due to the residual effects of resuspended fine sediments.
