# The 22 April 1991 Limón, Costa Rica tsunami field survey

## Estudio de campo del tsunami de Costa Rica del 22 de abril de 1991

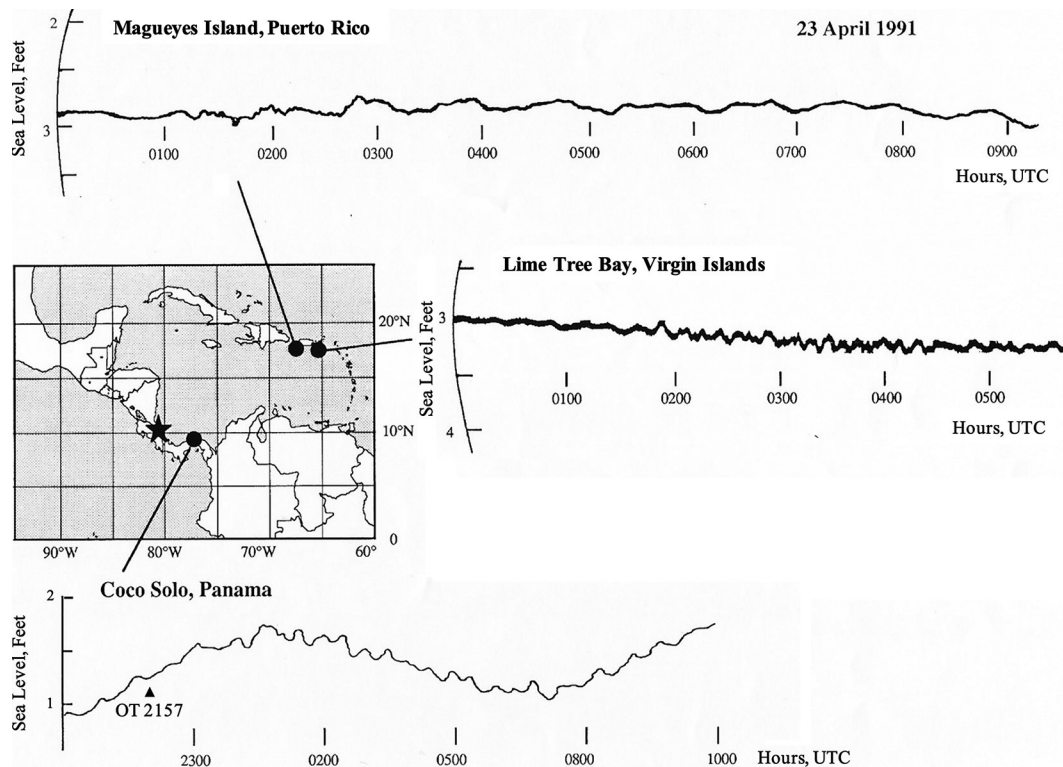
Fig. 2: Tide gauge records of the 1991 Limón, Costa Rica tsunami. Inset map shows the location of the tide gauges with respect to the epicenter (star). Vertical record scale in feet, horizontal scale in hours (Coordinated Universal Time, UTC). (a) Coco Solo (Cristobal) Panama [9.35° N, 79.92° W]. Earthquake Origin Time (2157 UTC) shown by arrow. Maximum peak to trough amplitude is approximately 3 in (7.6 cm); both (b) Magueyes Island, Puerto Rico [18.22°N, 67.16°W] and (c) Limetree Bay, St. Croix, Virgin Islands [17.69°N, 64.75°W] show maximum peak to trough amplitudes of ~ 3 in (7 cm).

A tsunami or series of waves with heights,  $h_{\max}$ , of 2 to 3 m were reported by eyewitnesses along the coast from Rio Matina, Costa Rica to Bastimentos Island, Panama following the earthquake (Fig. 1) indicating a tsunami magnitude,  $m$ , of ~1 (where  $m = \log_2 h_{\max}$ ; Table 1; Iida, Cox & Pararas-Carayannis, 1967; Iida, 1970). The Cristobal tide gauge at Coco Solo, Panama (9.35° N, 79.92° W, 320 km southeast of the source zone) recorded a maximum peak to trough amplitude of 7.6 cm (3 in) 1 hour after the earthquake (Fig. 2). Approximately 3½ hours later, bubbler tide gauges in Magueyes Island, Puerto Rico (18.22° N, 67.16° W) and Limetree Bay, St. Croix, Virgin Islands (17.69° N, 64.75° W) both recorded disturbances of about 7 cm peak to trough (Fig. 2). Appendix 1 in the Electronic Supplement contains copies of the three tide gauge records.

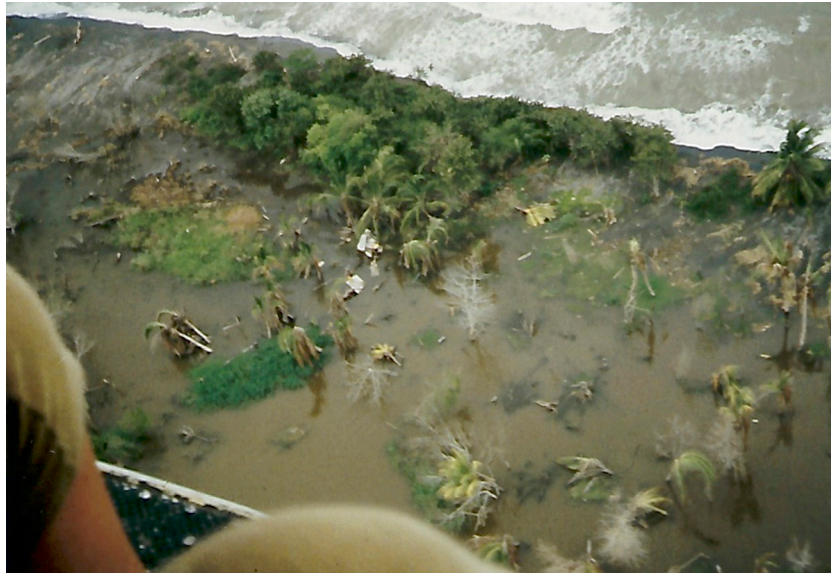
Fig. 4: Near vertical air photograph of an area flooded by the tsunami at Playa de Julio Abrego, Panama (site 15, Fig. 1). Note the onshore flooding and the NE-SW trend of fallen palm trees.

14		9.51°	82.49°				
15	Playa de Julio Abrego	9.43°	82.41°	A farmer reports that the before the quake occurred, the sea was very quiet. Minutes after the event the sea receded between three and six times. The last wave was the largest and the water penetrated 100 m inland. The NE-SW trend of fallen palm trees and other types of vegetation surrounded by sand and onshore flooding is seen in Fig. 4.			Beach
16	Changuinola River/ Tiri-bibi Pt.	9.42°	82.38°	Figure 5 shows the onshore flooding in this area and a zone of brown grass and vegetation parallel to the coastline. Sand deposition and fast currents			Beach

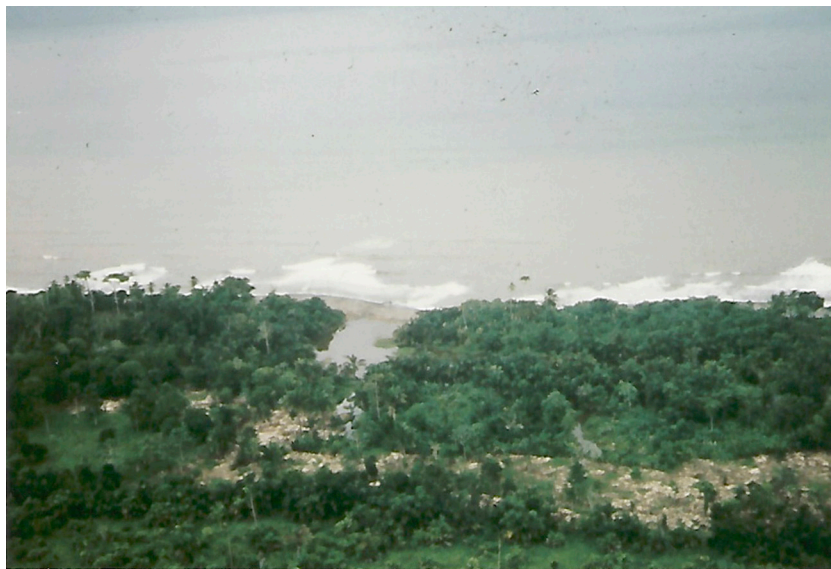
Fig. 5: Near vertical air photograph of an area inundated by the tsunami between the mouth of the Rio Changuinola and Tiribibi Point, Panama (site 16, Fig. 1). Note the onshore flooding in the center of the photograph and zone of brown vegetation in the lower portion of the photograph.

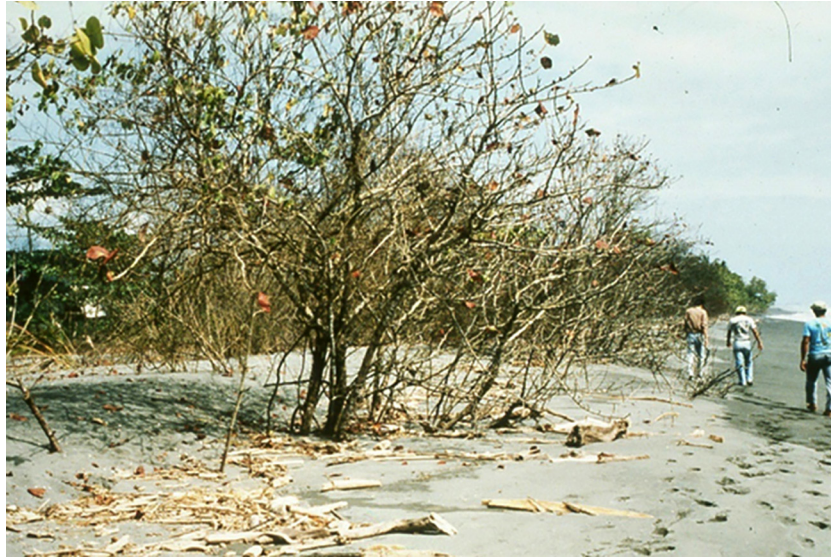
Fig. 6: Tsunami sand deposits on the beach at the San-San Natural Refuge, Panama (site 13, Fig. 1).

Following the initial retreat, two principal types of runup behavior were observed. The first consisted of a 2 to 3 m high wave which advanced rapidly to the beach. Runup varied according to location and ranged from 10 to 100+ m inland. This behavior was observed at the mouths of major rivers in the area, including Boca Matina (#1) and Bocas del Pantano (#2). Waves were noted to have overtopped 3 m high dikes at the mouth of the Moin River (#5) and penetrated 1 km upstream at the Estrella River (near #7). Widespread liquefaction along the coast and compaction-induced subsidence of poorly consolidated sediments appear to have locally amplified runup effects at the mouths of large rivers (EERI, 1991; Denyer et al., 1994). Large waves were noted along beaches at Puerto Viejo (#8), Punta Uva (SE sector) (#10), Manzanillo (#11), and Gandoca (#12). While no significant damage resulting from the runup was reported by observers, two drownings are reported to have occurred in the canal near Matina (#1) due to the sudden increase in water height. A third drowning has also been documented near Moin (Chacón-Barrantes, personal communication, 2021). Large waves and fast currents were also noted at sites facing the Caribbean in Bocas del Toro, Northwestern Panama. Onshore flooding was noted at Playa de Julio Abrego (#15, Fig. 4), Tiribibi Point (#16, Fig. 5), and Lime Point (#17). Elsewhere, observers described the water activity as a series of strong currents (West Knapp (#18), Ground Creek (#19) and Nancy Key (#23)). Sand deposition by the tsunami was also noted by the respondents at many locations (12 Millas de Moin (#3), Westfalia (#6), Manzanillo (#11), and Gandoca (#12)). At the San-San Natural Refuge (#13, #14), a layer of sand, approximately 1 m thick was deposited on the beach creating dunes and covering turtle nests (Fig. 6).

Information about the behavior of recent smaller tsunamis provides a valuable context for interpreting accounts of earlier Caribbean earthquake-related tsunamis. The deposition of sand near the mouth of the San-San River in 1991 is similar to descriptions of tsunami sand deposited on the coast near Gandoca and Monkey Point, near the Costa Rica-Panama border, during the 7 May 1822 ( $M_s$  7.5+) earthquake and tsunami (Roberts & Irving, 1827). Flooding was also noted to have occurred in bays and the mouths of rivers along the Caribbean coast of Costa Rica (González-Viquez, 1910). Farther east, the 7 September 1882 earthquake ( $M_s$  8.3), located in the North Panama Deformed Belt offshore of the San Blas coast of Northeastern Panama, created a tsunami with 2 to 3 m high waves, great destruction, and nearly 100 deaths on the islands of the San Blas archipelago. The French Panama Canal Company tide gauge near Colon recorded a maximum height of 62 cm (Viquez and Toral, 1986; Mendoza and Nishenko, 1989). The April 26, 1916 ( $M$  6.9) Almirante, Panama earthquake also created a small local tsunami that is reported to have covered the southern tip of Carenero Island in the Bocas del Toro Archipelago minutes after the event (Reid, 1917; Duda, Khattri, Purcaru & Schick, 1990).

7	Cahuita	9.74°	82.84°	The sea receded 75 m then returned slowly to a level lower than previous. Dead fish were observed.		38	Reefs
8	Puerto Viejo	9.66°	82.76°	The sea receded 100 m followed by a large wave, receded again and was followed by a large wave with 30 -70 m runup. Sand movement and dead fish were also noted.	155	38-45	Reefs
9	Final de Cocles	9.64°	82.72°	The sea receded 20 m then returned slowly over a 5 - 6 min period with no runup.		29-54	Beach and Cliffs
10	Punta Uva	9.64°	82.69°	Water retreats 400–600 m	200	40-45	Beach
11	Manzanillo	9.63°	82.66°	The sea receded 180 m and returned in 5 min to flood 30 to 70 m inland. Sand movement and 1.5 m sand mounds were deposited.	83-130	30-40	Beach
12	Gandoca	9.60°	82.60°	The sea receded 300 m in 5 min and returned to flood about 70 m inland. Sand Movement.	125	30-40	Beach
Panama							
13	San-San Natural Refuge	9.54°	82.53°	Tsunami waves deposited a great deal of sand on the beach near the mouth of the San-San River, a wildlife refuge near the Costa Rica border, creating dunes which covered numerous turtle nests with approximately 1 m of sand and caused a decrease in the number of newborn turtles (see Fig. 6).			Beach

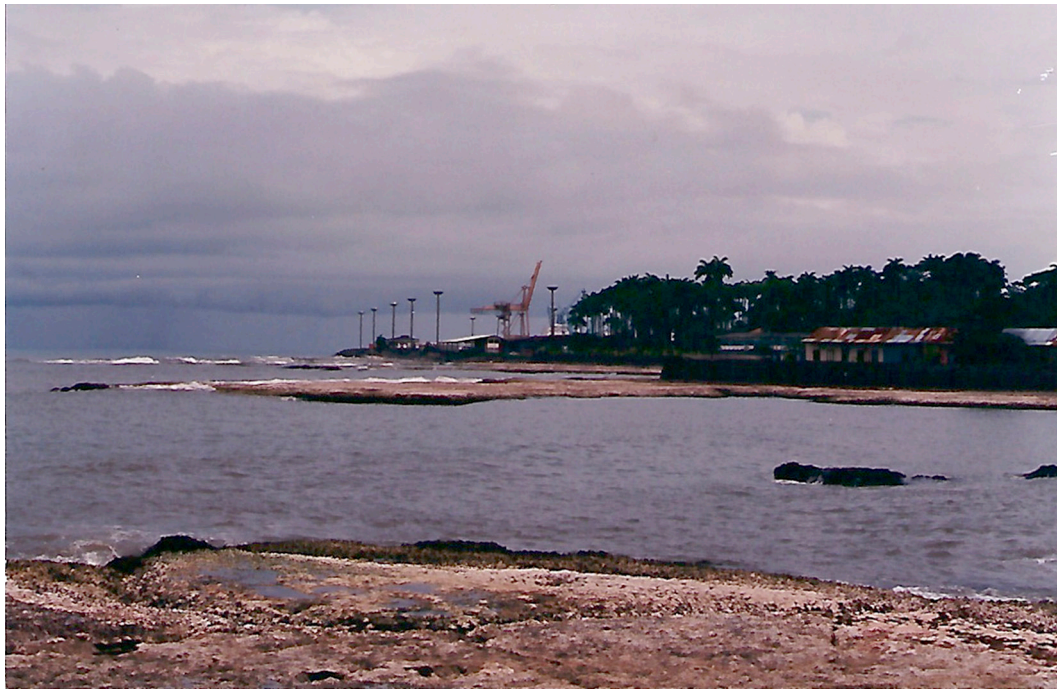
Fig. 7: Coseismic coastal uplift near Limón City, Costa Rica.

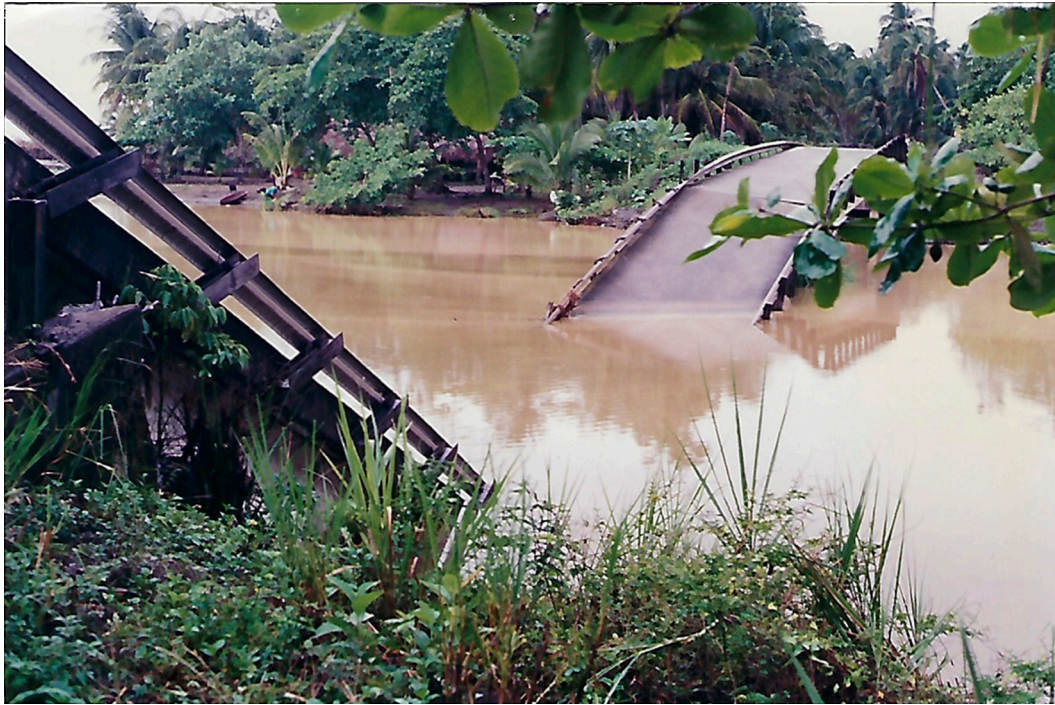
Fig. 8: Damage to the Vizcaya River bridge, 10 km south of Limón, due to soil liquefaction and lateral spreading.

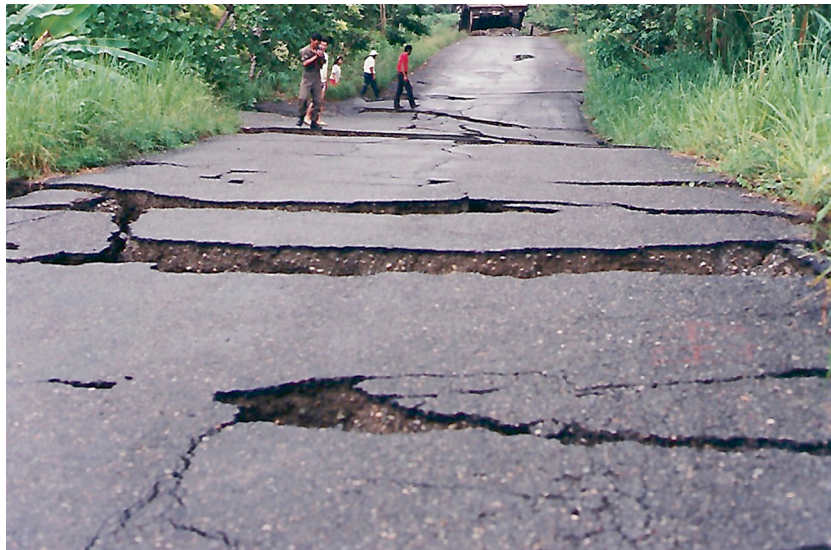
Fig. 9: Road damage on the Vizcaya River bridge approach due to liquefaction and lateral spreading.
